Power Quality Case Studies

By : Farhad Yazdi
Reference :

From the Fluke Digital Library @
www.fluke.com/library

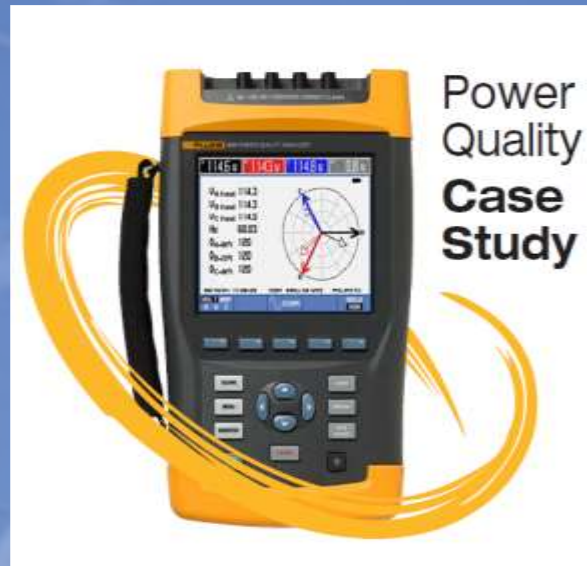
You could almost call it a happy accident. During a routine job at a large industrial facility, an electrical maintenance worker set a plastic kit on top of a nearby transformer. By the time he reached back for it a few minutes later, it had started to melt!

Measuring tools: Fluke 434 Power Quality Analyzer

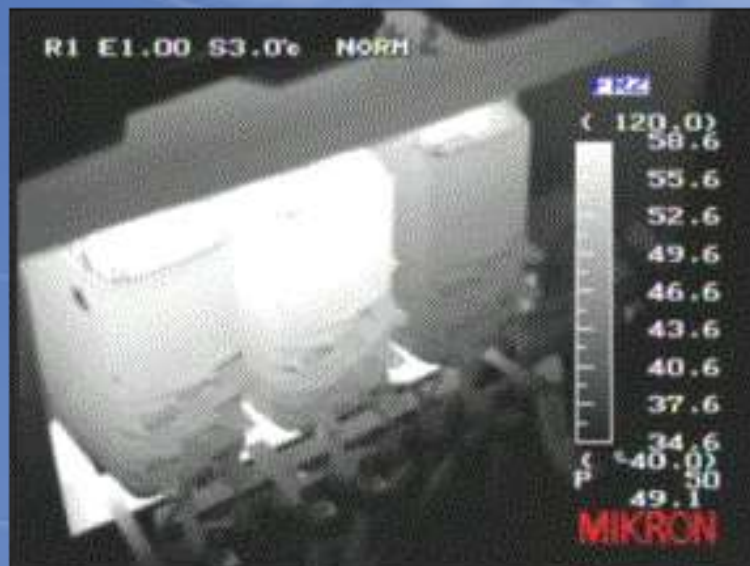
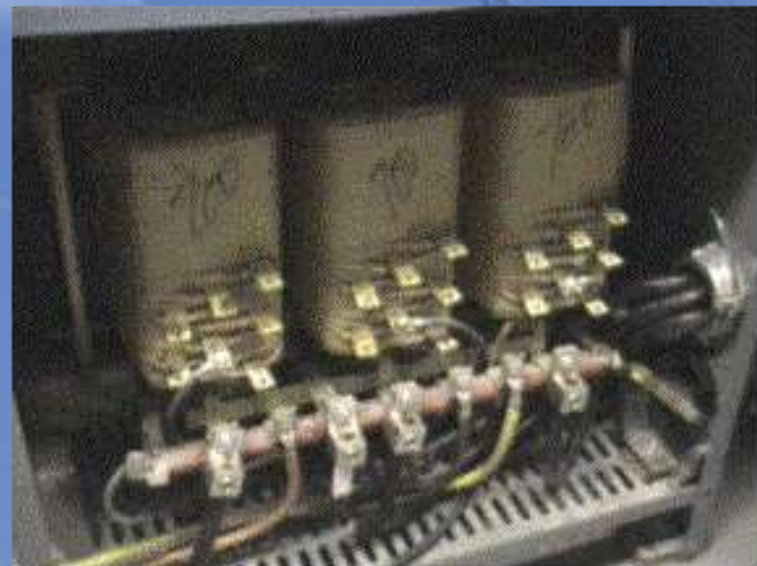
Above thermal and daylight images show uneven heating in the windings of a three phase step-down transformer, most likely due to harmonics.

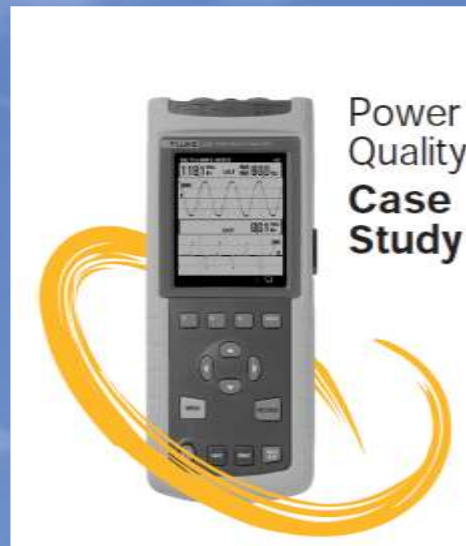
Measuring tools: Fluke 43B Power
Quality Analyzer

The engineer recorded the following data
using the Fluke 43B:

**Secondary voltage total harmonic
distortion: 2.7 %**

Secondary voltage balance: within 1 %

Secondary current: 57 A rms

The voltage measurements do not show anything abnormal. The voltage total harmonic distortion is well within the maximum allowable value of 5 %. Voltage balance between phases also looks good. The secondary current of 57 A indicates the client was correct in stating the transformer was lightly loaded. No overheating was noted.

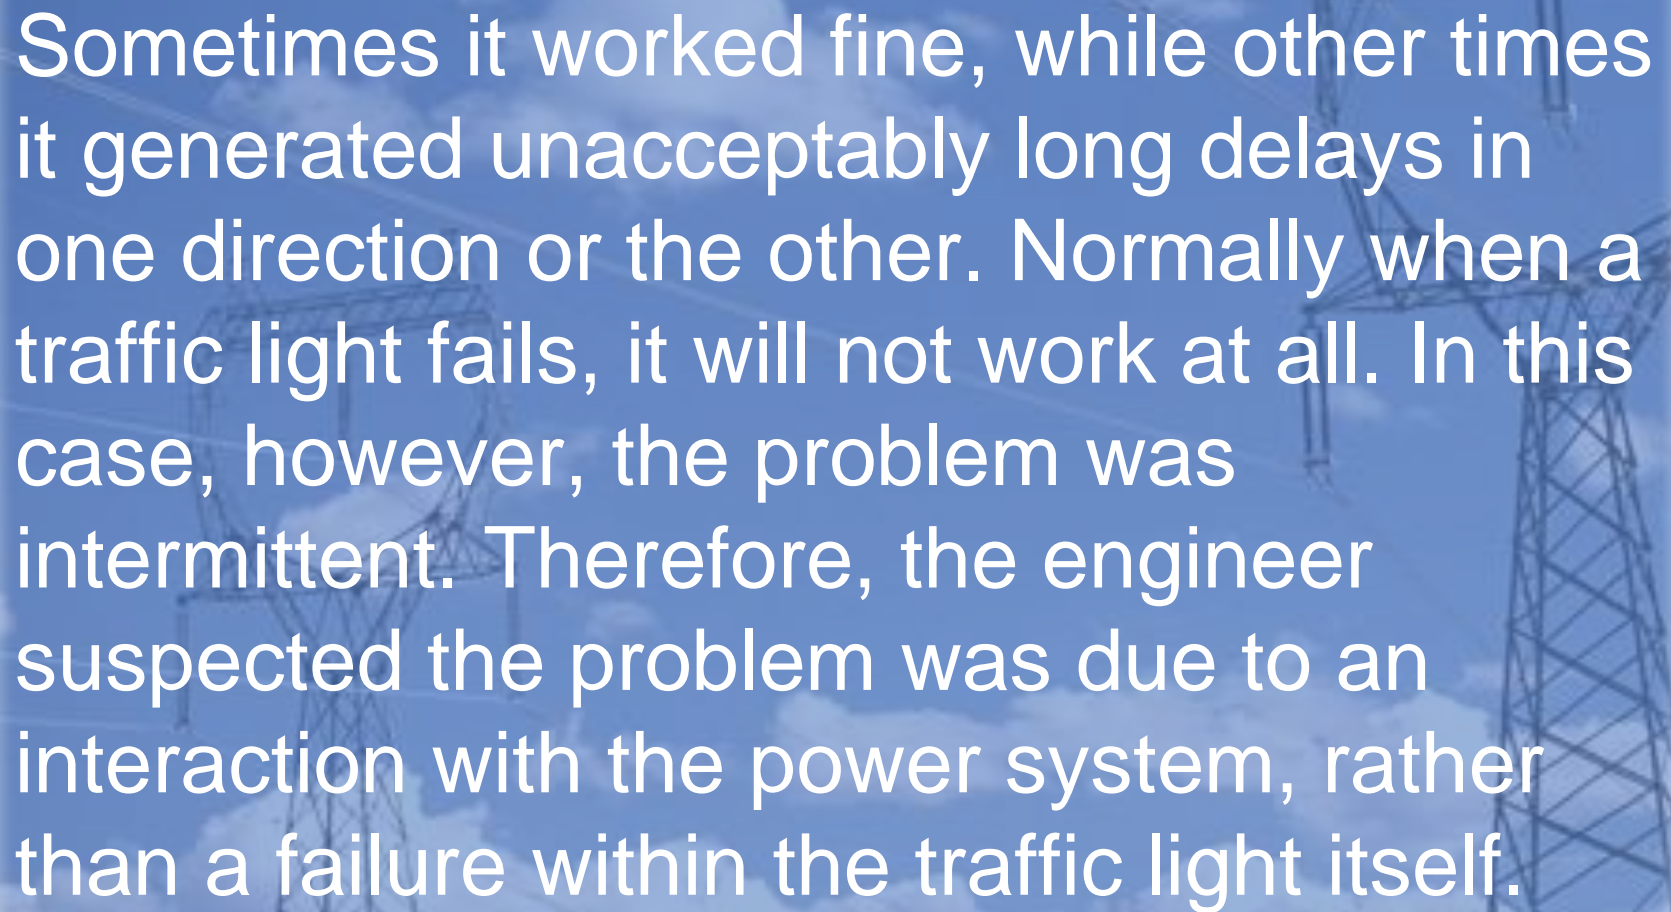
This case history came from an electric utility engineer assigned to maintain the power systems for several small towns in the western U.S. The case history began with a call from a local police department. The officer explained that the traffic light at the main intersection of town was randomly malfunctioning.

Sometimes it worked fine, while other times it generated unacceptably long delays in one direction or the other. Normally when a traffic light fails, it will not work at all. In this case, however, the problem was intermittent. Therefore, the engineer suspected the problem was due to an interaction with the power system, rather than a failure within the traffic light itself.

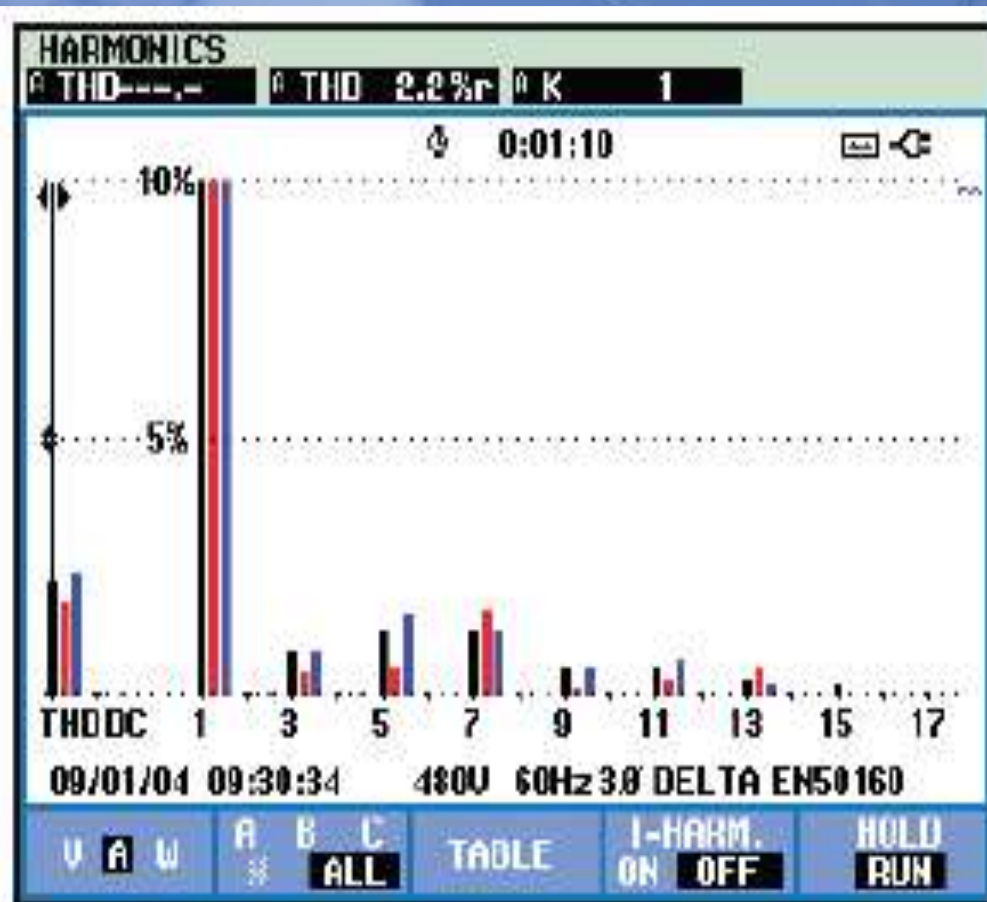
Fig. 7 Harmonics

HARMONICS TABLE			
0:02:03			
Volt	AB	BC	CA
THD%r	0.2	0.2	0.3
H3%r	0.0	0.1	0.1
H5%r	0.2	0.2	0.2
H7%r	0.2	0.2	0.2
H9%r	0.0	0.0	0.0
H11%r	0.0	0.0	0.0
H13%r	0.0	0.0	0.0
H15%r	0.0	0.0	0.0
09/01/04 09:31:26 480V 60Hz 3Ø DELTA EN50160			
		BACK	TREND
		HOLD RUN

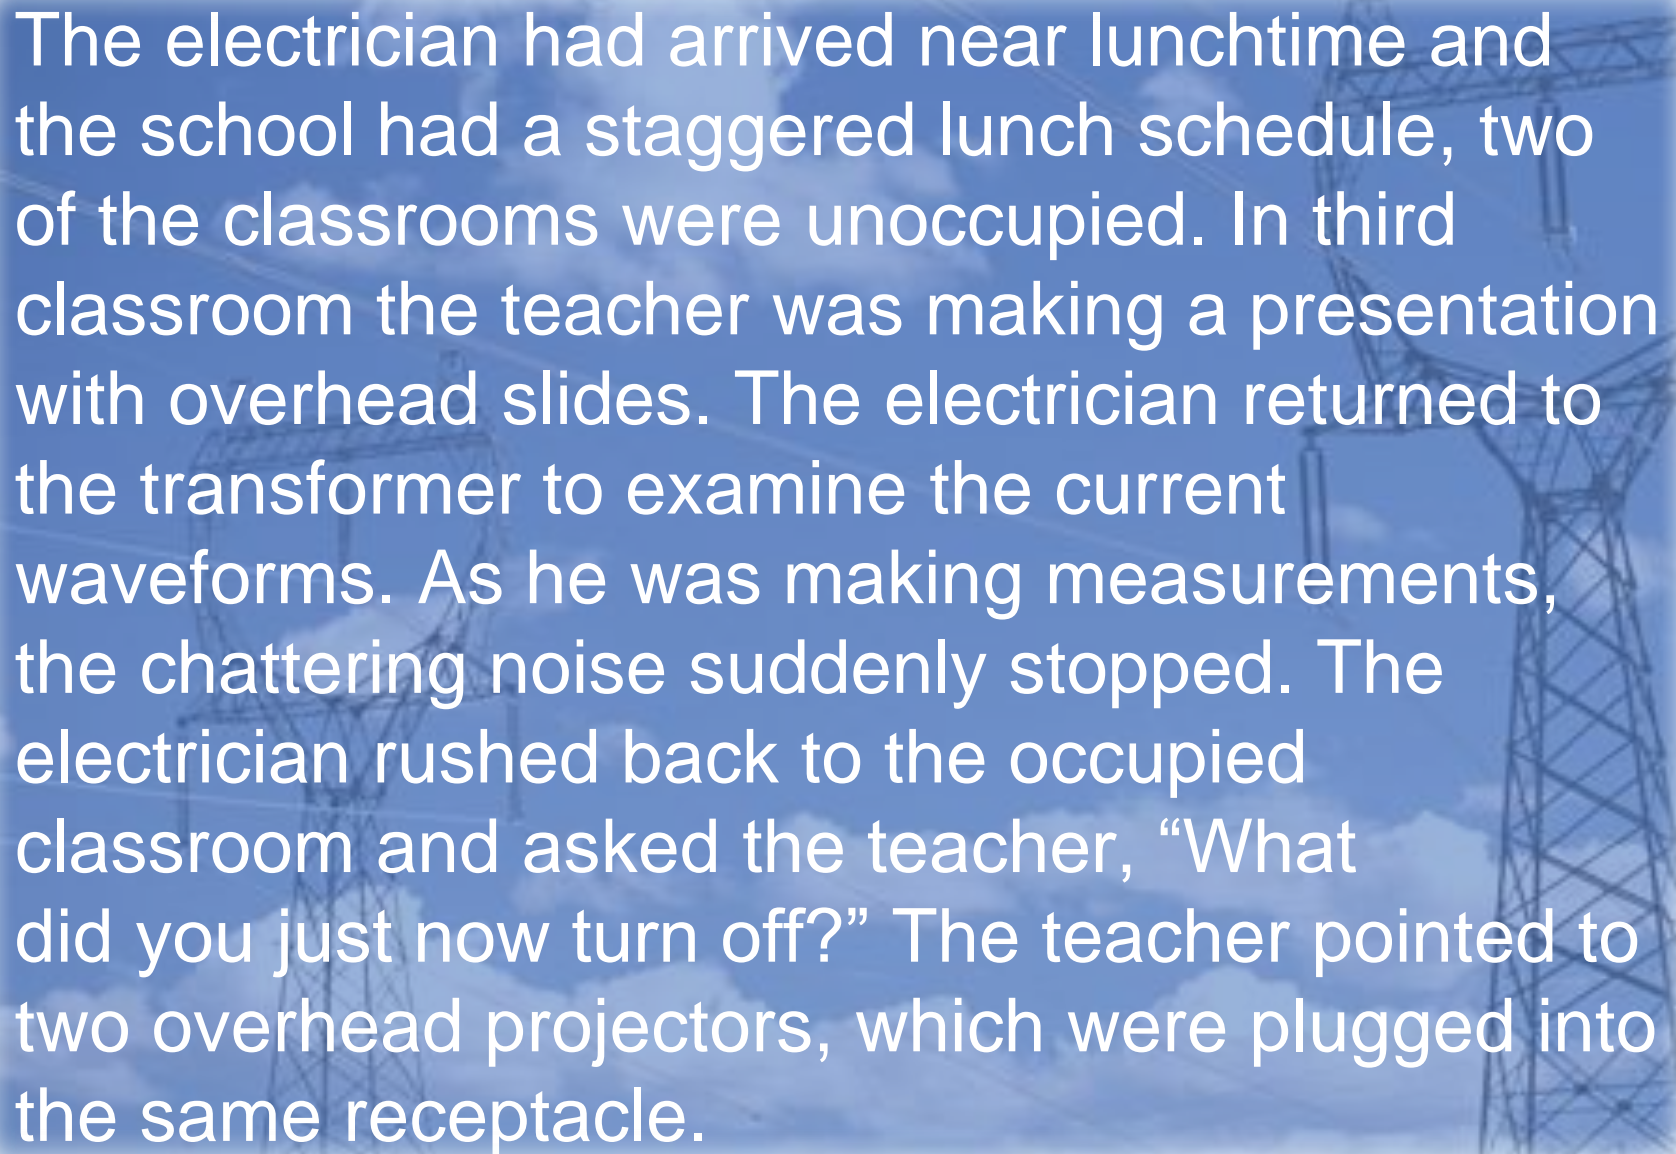
This case history involves an electrician who works for a large suburban school district. One winter morning, the electrician received a call from a local school. The caller said a transformer supplying power to three portable classrooms as making a “chattering” noise, as if something were loose inside (Fig. 1). Load measurements showed the transformer was heavily loaded, but not overloaded. The loads included lights, electric heat, and a few computers. Most of the load was electric heat, due to cold winter weather.

The electrician had arrived near lunchtime and the school had a staggered lunch schedule, two of the classrooms were unoccupied. In third classroom the teacher was making a presentation with overhead slides. The electrician returned to the transformer to examine the current waveforms. As he was making measurements, the chattering noise suddenly stopped. The electrician rushed back to the occupied classroom and asked the teacher, "What did you just now turn off?" The teacher pointed to two overhead projectors, which were plugged into the same receptacle.

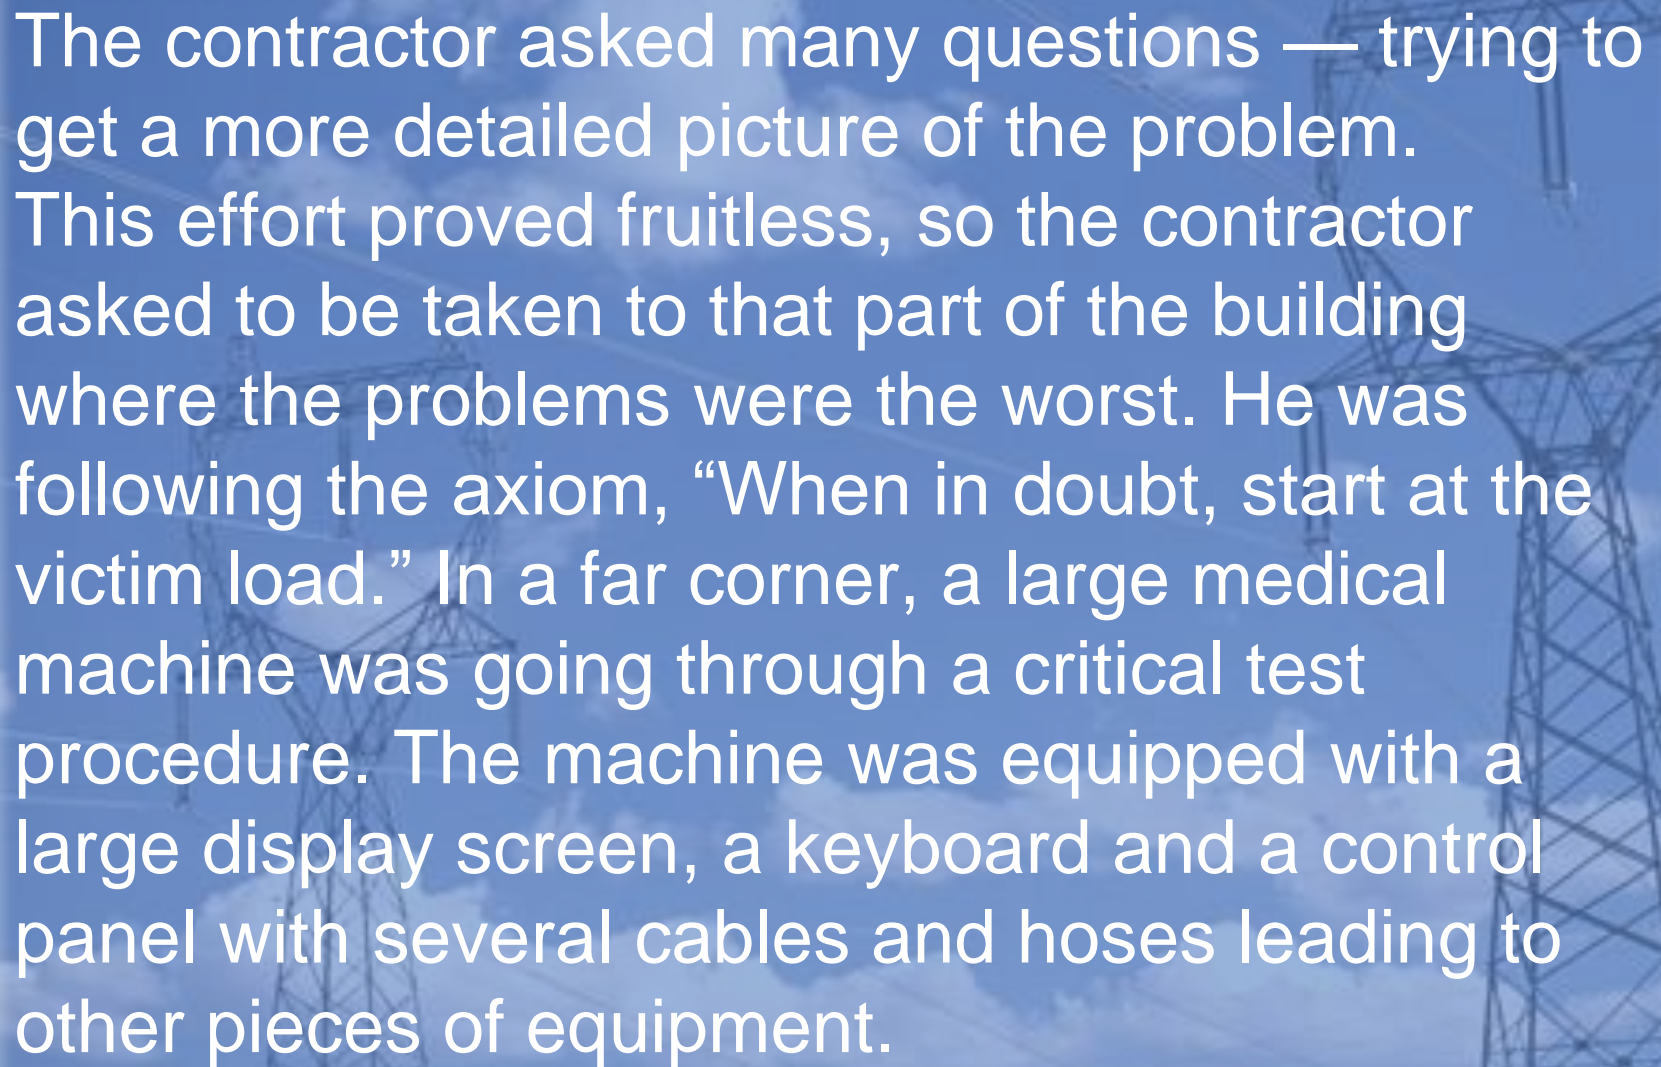
This case history is a classic example of the importance of a systematic approach to solving a problem. It involves a contractor who works with several high-technology manufacturing plants. The case began with an on-site visit to a building manager who was frustrated with his electrical system. According to the manager, nothing electrical in his building seemed to work properly and no one had been able to determine why or offer a solution. The manager went on to say that three of his electricians had quit and that he was now in real trouble.

The contractor asked many questions — trying to get a more detailed picture of the problem. This effort proved fruitless, so the contractor asked to be taken to that part of the building where the problems were the worst. He was following the axiom, “When in doubt, start at the victim load.” In a far corner, a large medical machine was going through a critical test procedure. The machine was equipped with a large display screen, a keyboard and a control panel with several cables and hoses leading to other pieces of equipment.

Since the measured value of the peak input voltage was only 135 V, the machine was running on a peak voltage that was already 6 V below the absolute minimum required. When the fan was turned on, the surge current drawn by the fan motor further reduced the voltage to a point where the power supply of the machine went out of regulation. This is what caused the machine to reset.

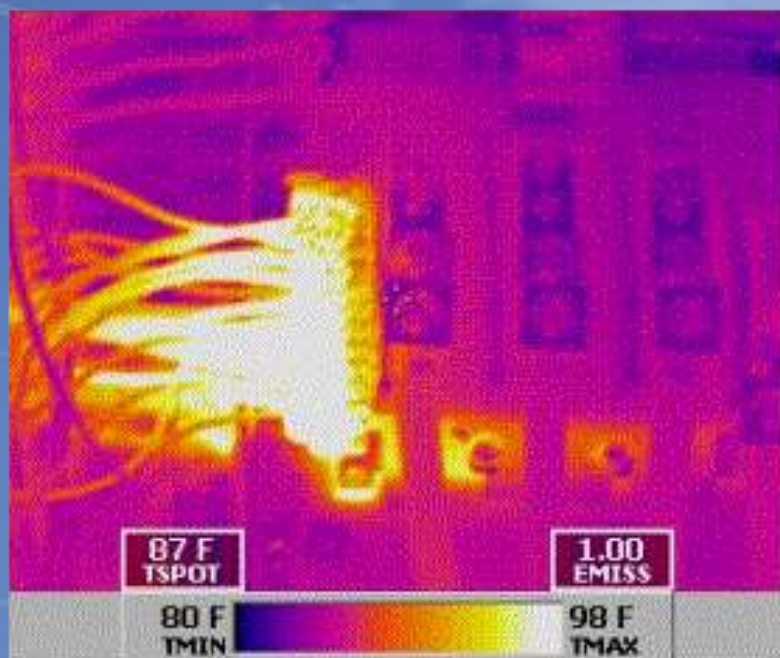
Above thermal images show an overheated neutral bus bar caused by third order, zero sequence harmonic currents.
